South Santiam Wetland Mitigation Bank Post- Construction Report

DSL Permit No. 60771-RF

USACE Permit No. NWP-2017-362

December 2019

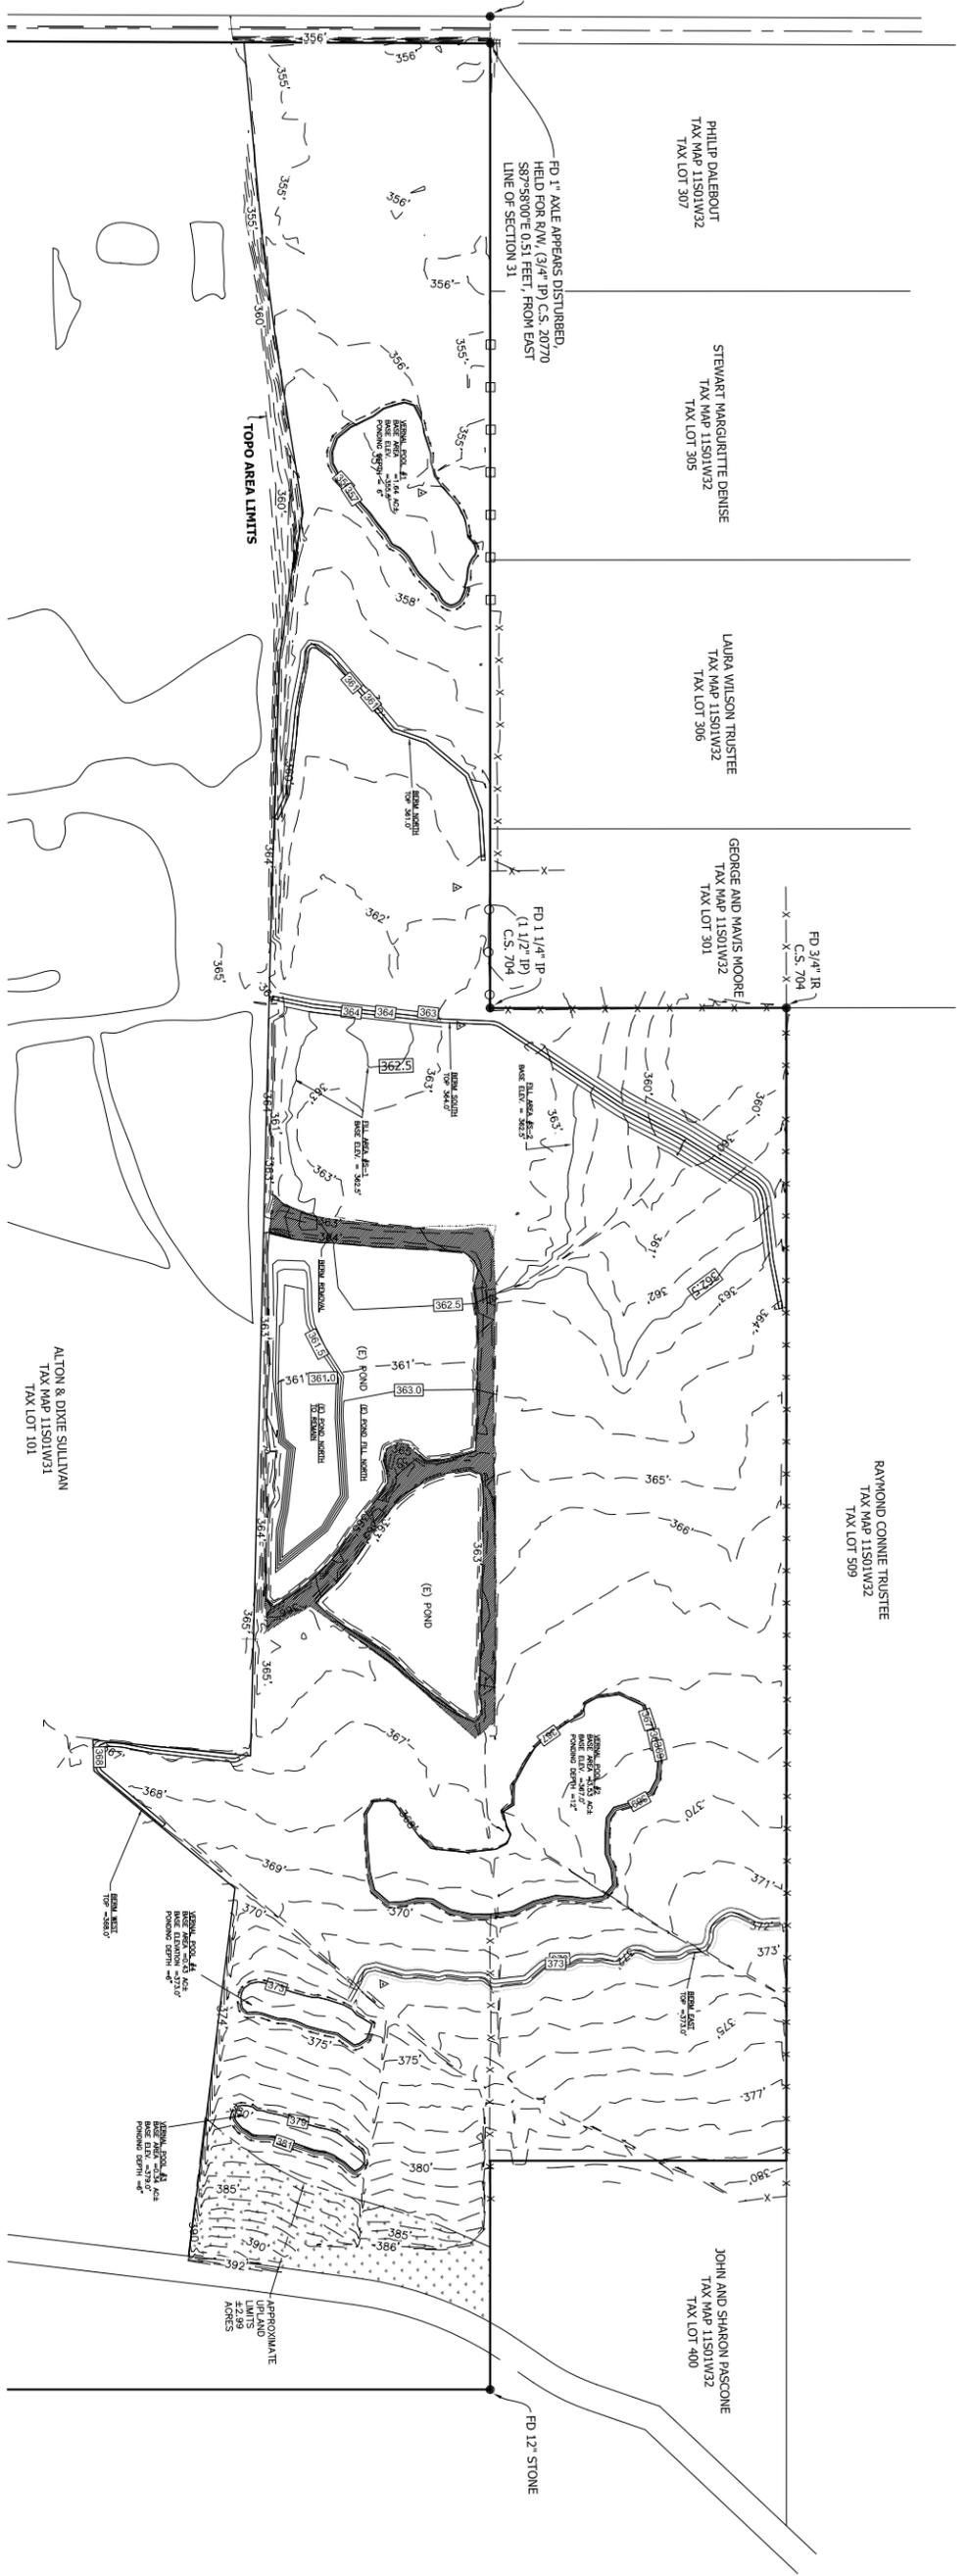
Sheet **C1.0**
SCALE: SEE BARSCALE

SITE PLAN
**SOUTH SANTIAM
MITIGATION BANK
LEBANON, OREGON**

Site grading began in early August with the removal of the existing sod layer within vernal pools and footprint of new berms. The upper-most layer was stockpiled along toe of new berms, to be placed on top of fill material after grading. The next layer of topsoil was stockpiled adjacent to work areas to be replaced after grading work. With concerns over non-native seed bank within the constructed levees of the farmed ponds, the majority of that material was placed as a base layer in filled areas to preclude germination. Once the topsoil and discarded soils were removed, mass grading began in the center of the site, working out from there. The scrapers and tractors worked on the majority of the topography alterations, filling ditches, building berms, and generally increasing the topographic diversity. Excavators, dozers, and dump trucks focused on mobilizing fill material. Following topsoil placement, finished areas were disked, harrowed and cultipacked to break up compaction and establish a suitable seed bed. In addition, the harrow and roller were utilized to create a gently undulating soil surface to increase topographic variation and diversify hydrology to ultimately increase diversity of plant communities. Final grading was completed in late September. The grading plan is included in attachment 1 and final grading as-built survey is included in Attachment 2 with 0.5-foot contour elevations.

With extensive field recognizance prior to compilation of final grading plan, deviations were minor. During site layout and associated fine scale topography surveying, several minor changes were made. The East berm was moved down slightly in the landscape to provide a greater buffer from swale entering in from East side of site. The small berm was moved from the 372' contour, to the 371' contour, and corresponding top elevation was reduced from 373' to 372', with all dimensions following original design. Due to larger than anticipated topographic variations within the footprint of vernal pool #2, it was broken into 3 separate vernal pools, encompassing approximately the same proposed footprint. Several small, slightly elevated areas were left between the pools to further diversify hydroperiods. Much of the vernal pool creation along the upland boundary on South end of site was based on observed soils. The clay layer was encountered quickly, and with elimination of the extensive drainage system, this area saturated quickly and its anticipated that post construction delineation will show a significantly reduced upland area.

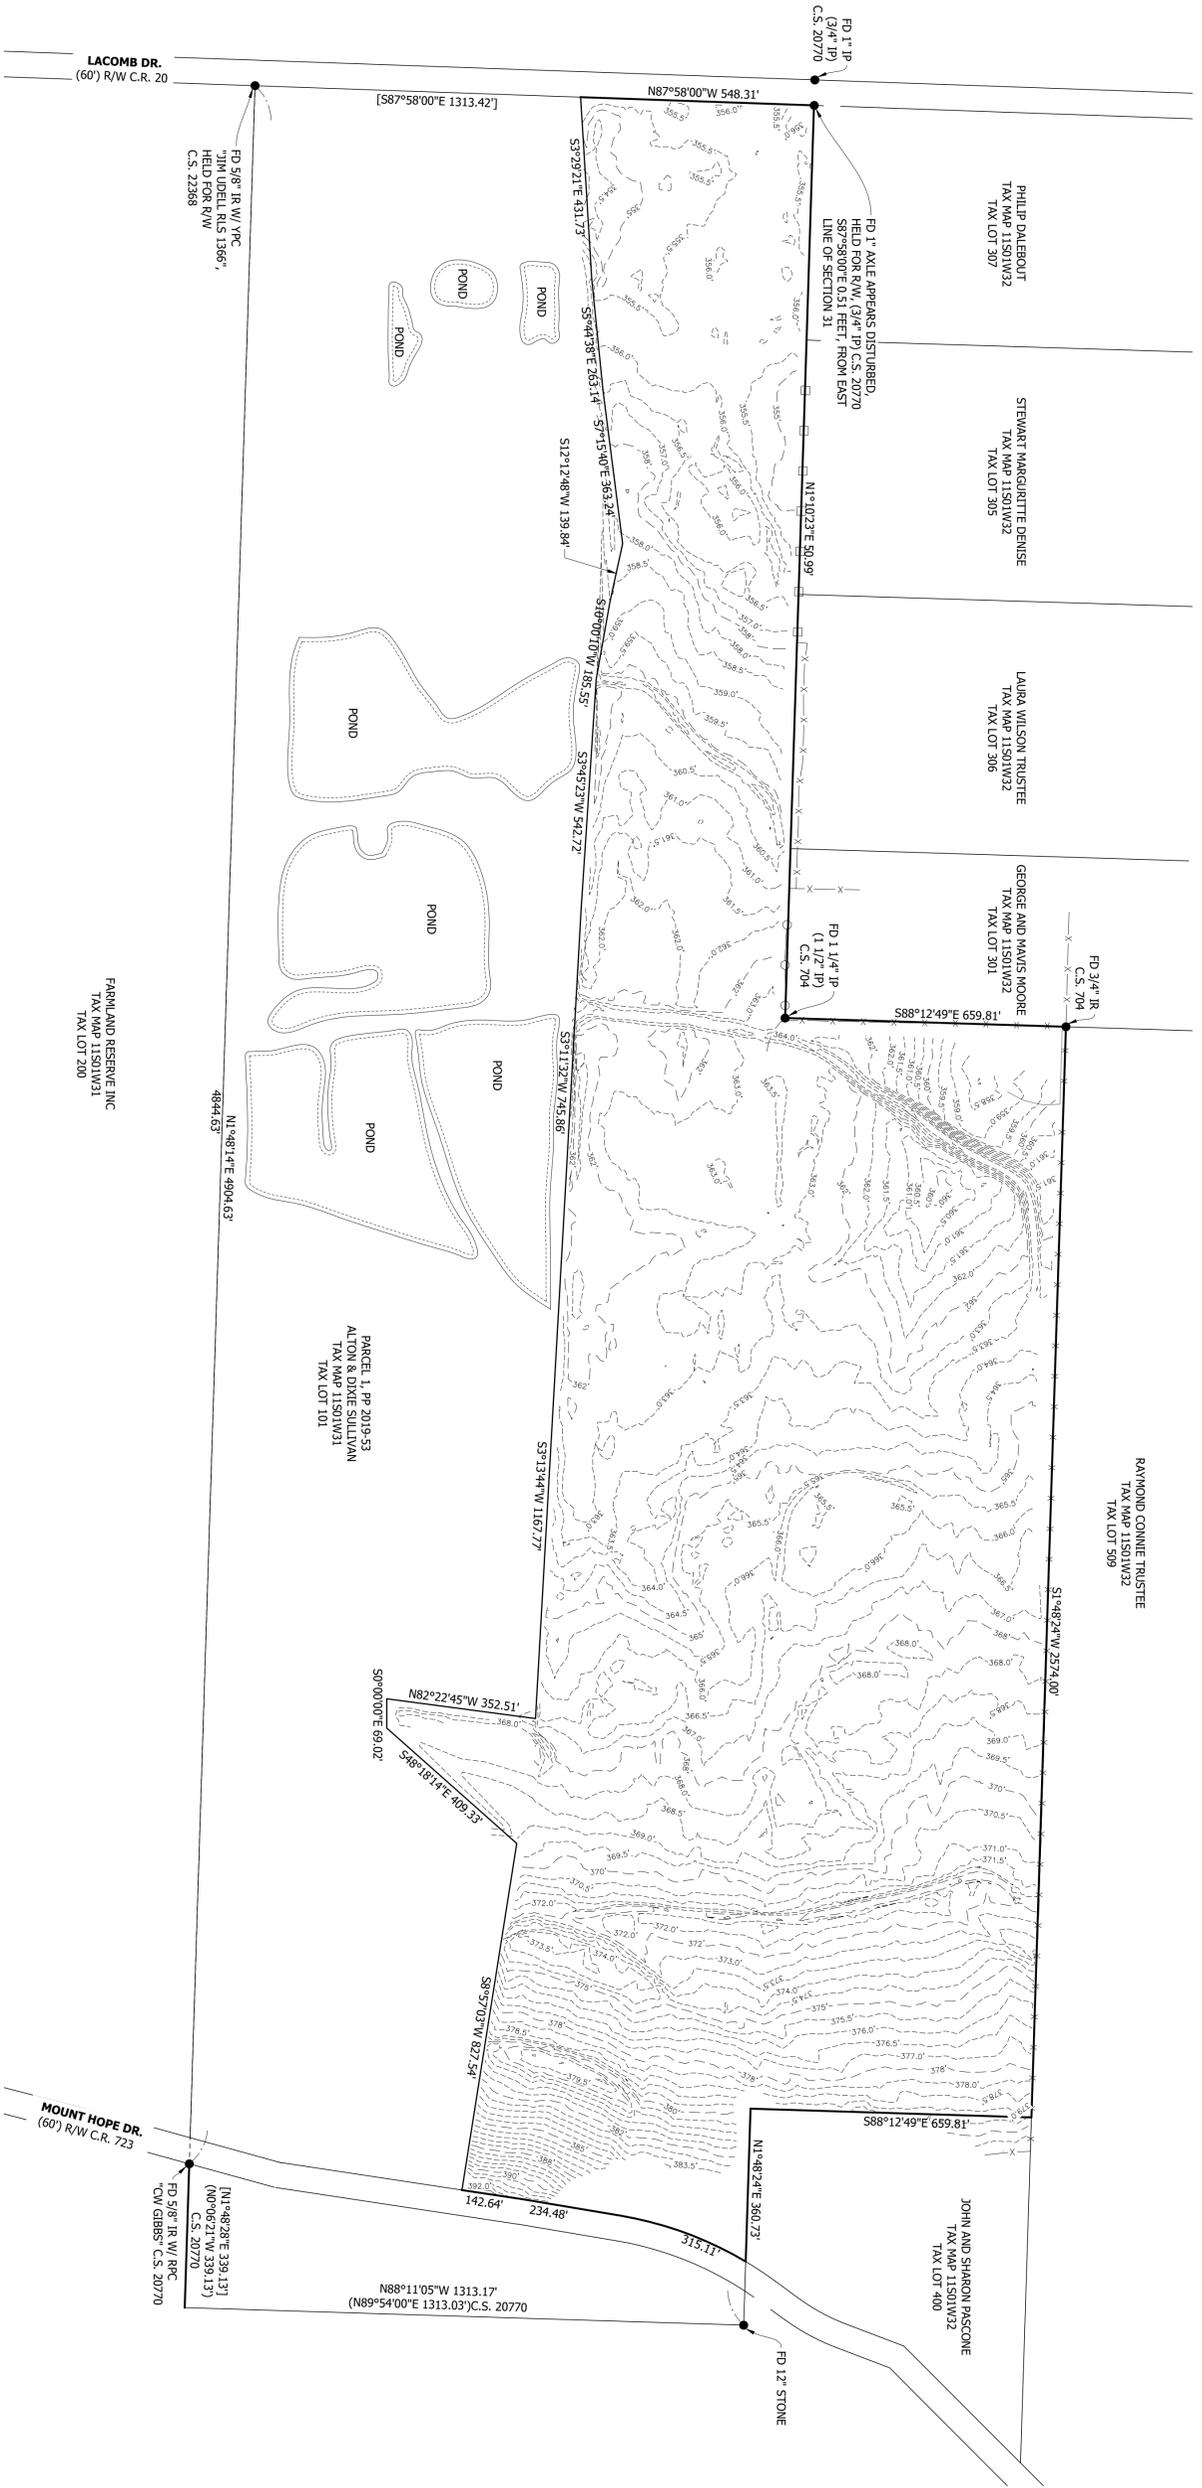
Sheet **1**
 SCALE: SEE BARSCALE

'AS-BUILT' TOPOGRAPHY MAP
PARCEL 2, PP 2019-53
TAX LOT 401, MAP 11.1W.32
LEBANON, OREGON
