# Alder Creek Restoration Project

## 2019 Monitoring Report Year 4

February 2020  
Revised August 2020

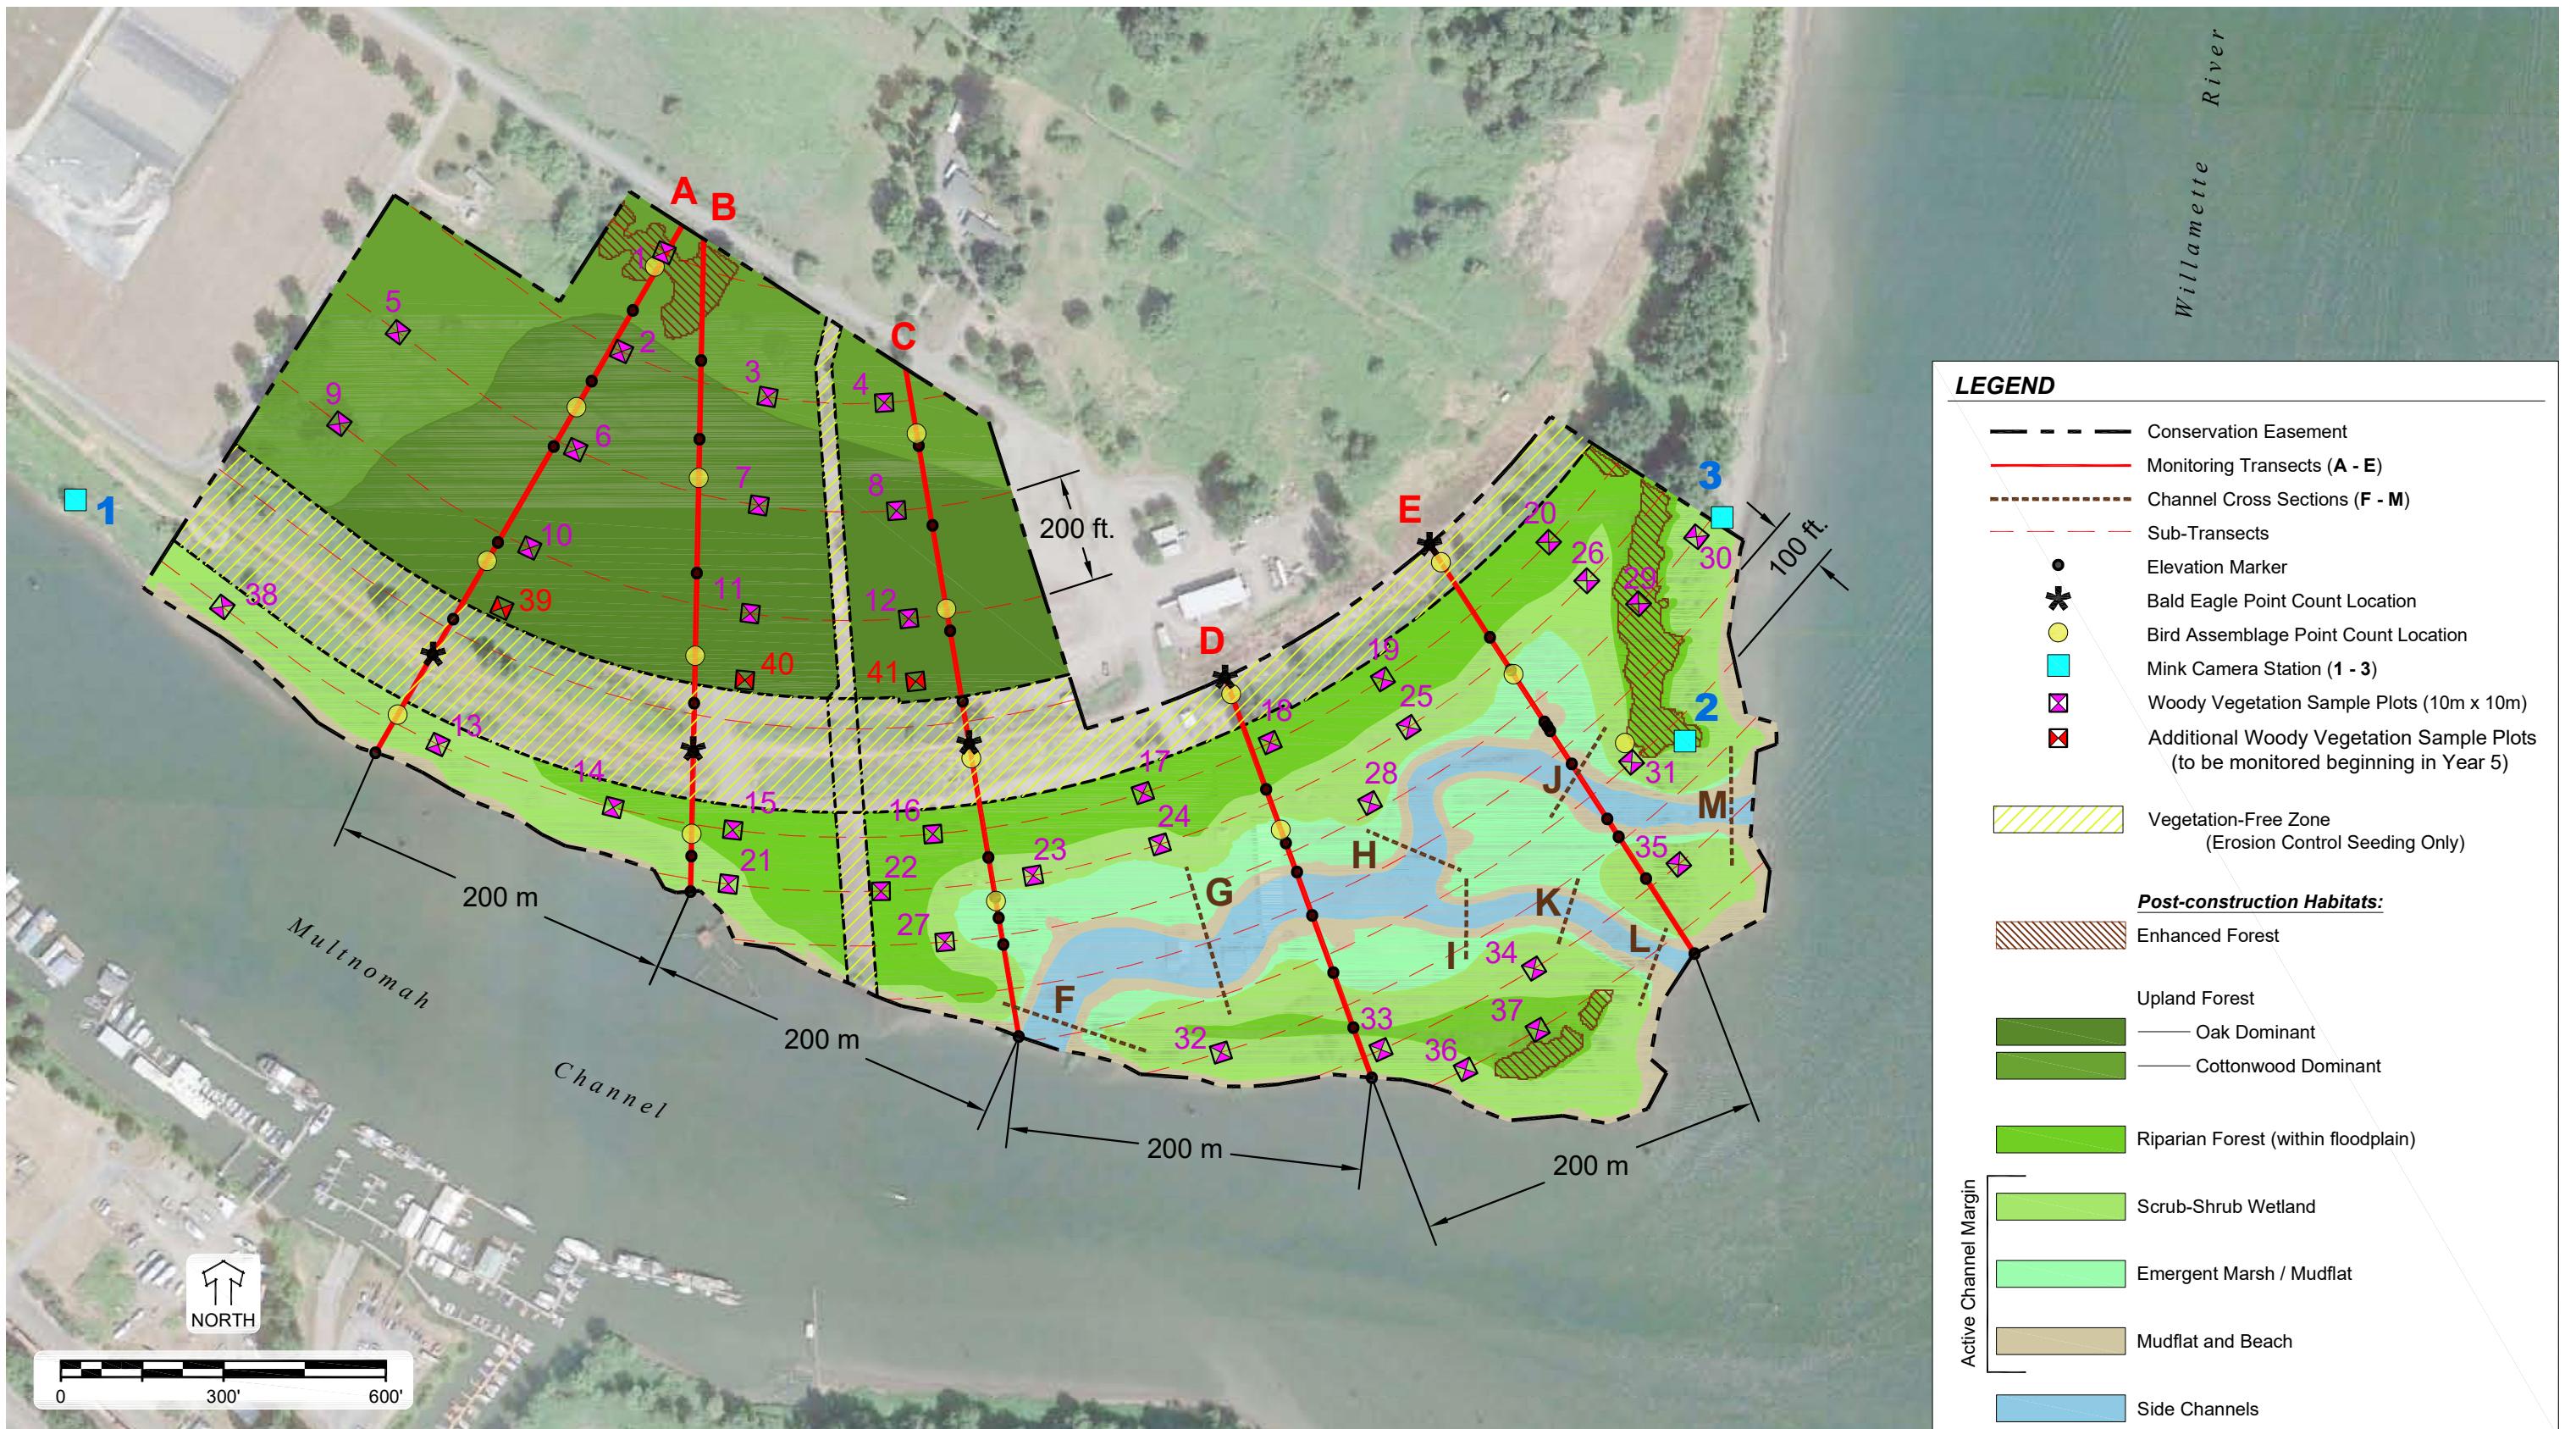
Figure 3  
Post-construction Monitoring

Quantitative monitoring data will be primarily collected using 10x10 meter sample plots along five main baseline transects running more or less north/south across the site (**Figure 3**). Beginning in Year 5, three additional sample plots within the upland forest will be monitored during the monitoring events within the upland forest. The locations of the three additional sample plots have been added to Figure 3.

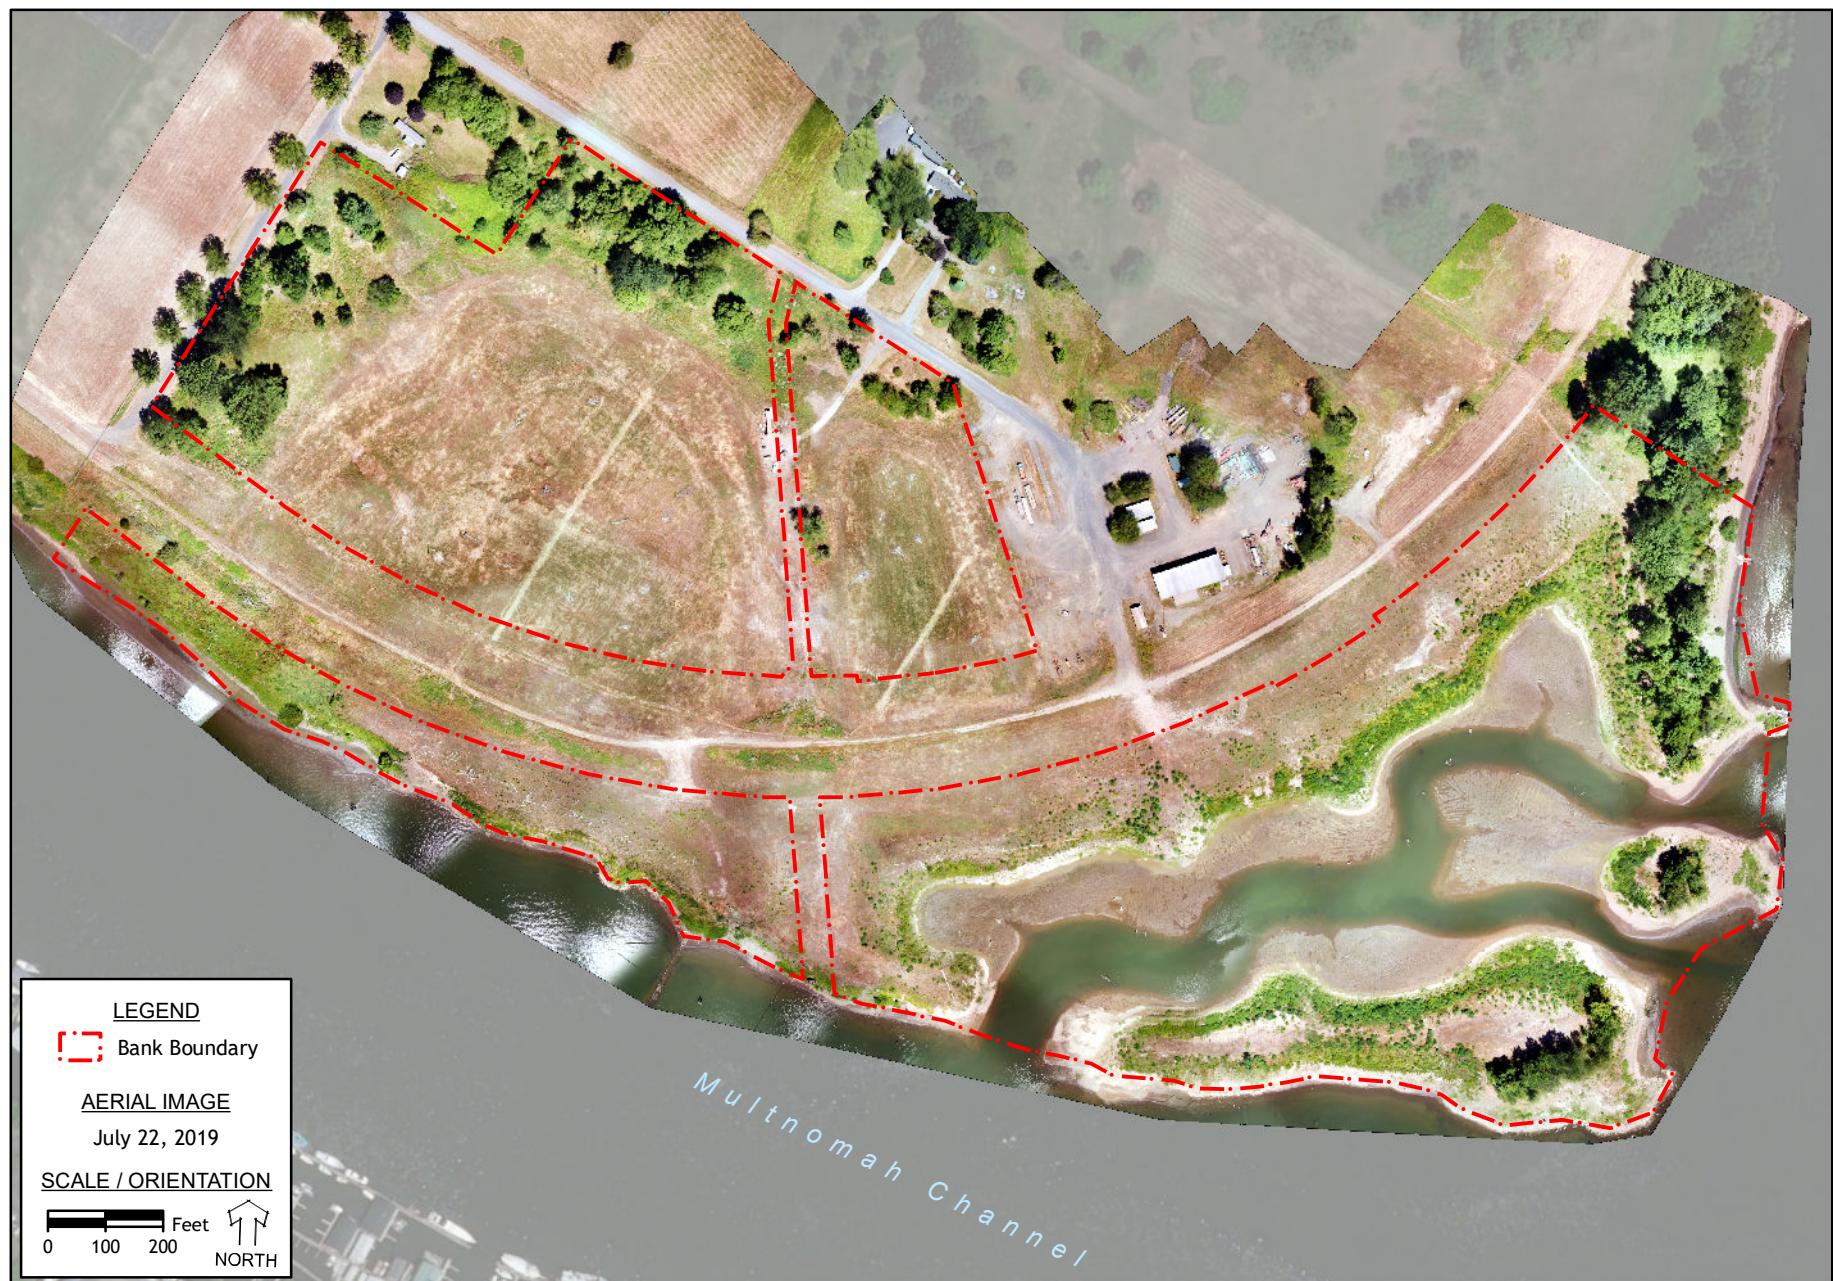
Figure 4  
2019 Aerial Photo

Aerial photos will be taken during late summer each year that aerial photography is required. This will allow a year to year comparison of the development of planted vegetation, geomorphology, and will allow the tracking of general changes to the Restoration Site that may be difficult to detect during surveys constructed from the ground.

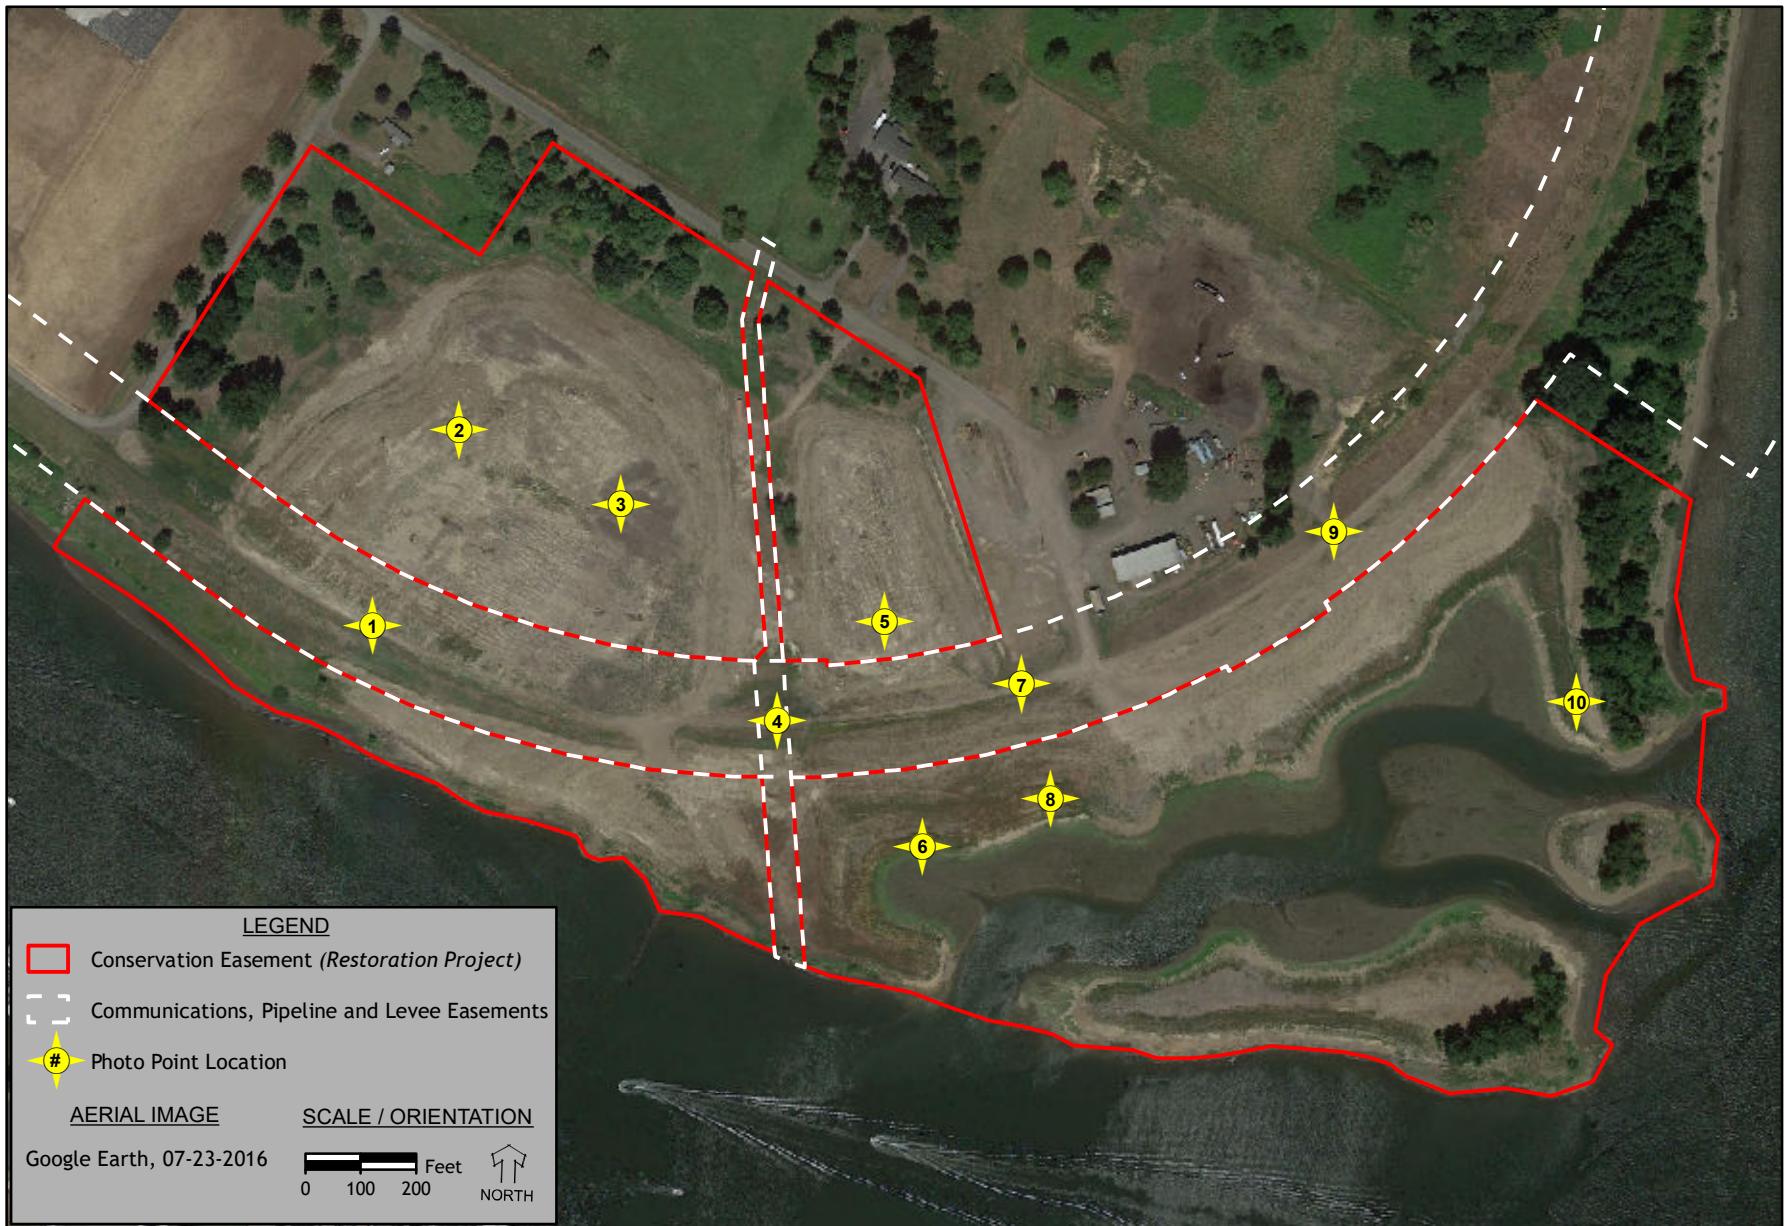
Figure 5a  
Photo Location Map

A total of 10 permanent photo points was established for the Project to document overall site conditions and provide a basis for year-to-year comparisons. Multiple photos in different directions were taken on September 16, 2019 from each photo point. A map of the photo points and corresponding photos can be found in **Figures 5a-5b**. Photo-documentation will continue during Year 5 (2020).

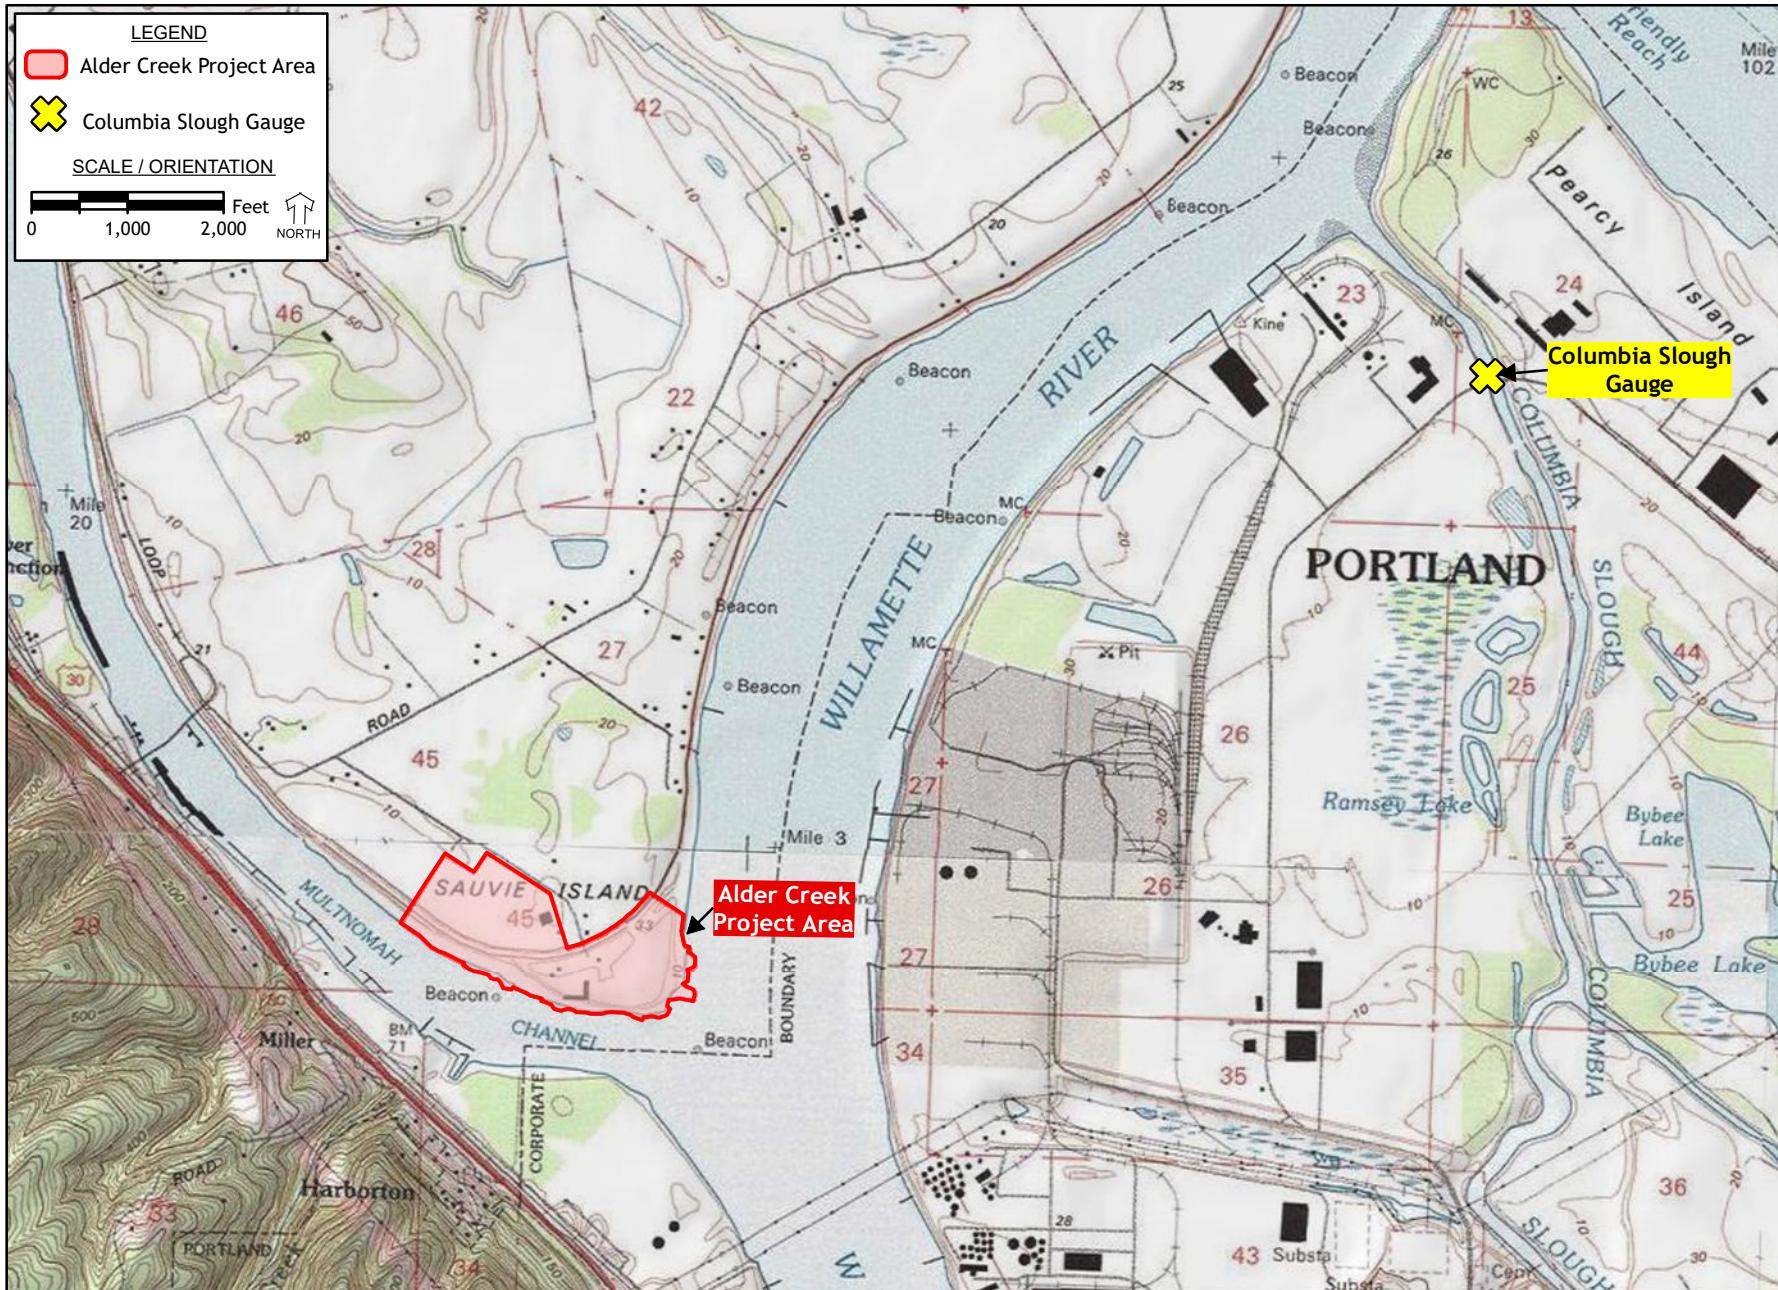
## Columbia Slough - USGS station ID: 14211820

Wildlands commonly utilizes NOAA and USGS water data stations to reference river elevations and hydrologic conditions on project sites. The USGS station at Columbia Slough (USGS 14211820 COLUMBIA SLOUGH AT PORTLAND, OR) has been determined to accurately and reliably provide a published record of the conditions and water levels at the Alder Creek Restoration Project. This station is located approximately 2 miles down-river of the Project site (see **Figure 6a**).

To determine the accuracy of this published data, the river elevation at the Project site has been surveyed on numerous occasions between 2010 and 2016 by both Wildlands' staff and by licensed surveyors from AKS Engineering and Forestry. The surveyed river elevation data has been compared to the closest published 15-minute interval "gage height" at the USGS Columbia Slough station. It has been found to accurately match with the survey data, with an average difference of less than 0.02 feet. Historic water data from this station can be downloaded and a clear picture of the hydrology of the Project site can be determined. The Columbia Slough gauge provides an excellent representation of water elevations at Alder Creek. Continuous water level data from the USGS water data station at Columbia Slough was used to document the water levels on the Project site during the Reporting Period (See **Figure 6b**). The water level data for the Reporting Period shows that river elevations in April and May were higher than average, while the rest of the year fell generally within the range of average. Because this data is available at any time throughout the year regardless of river level or weather, Wildlands' staff are able to use it to reference the water level and compare it to onsite conditions during field visits.

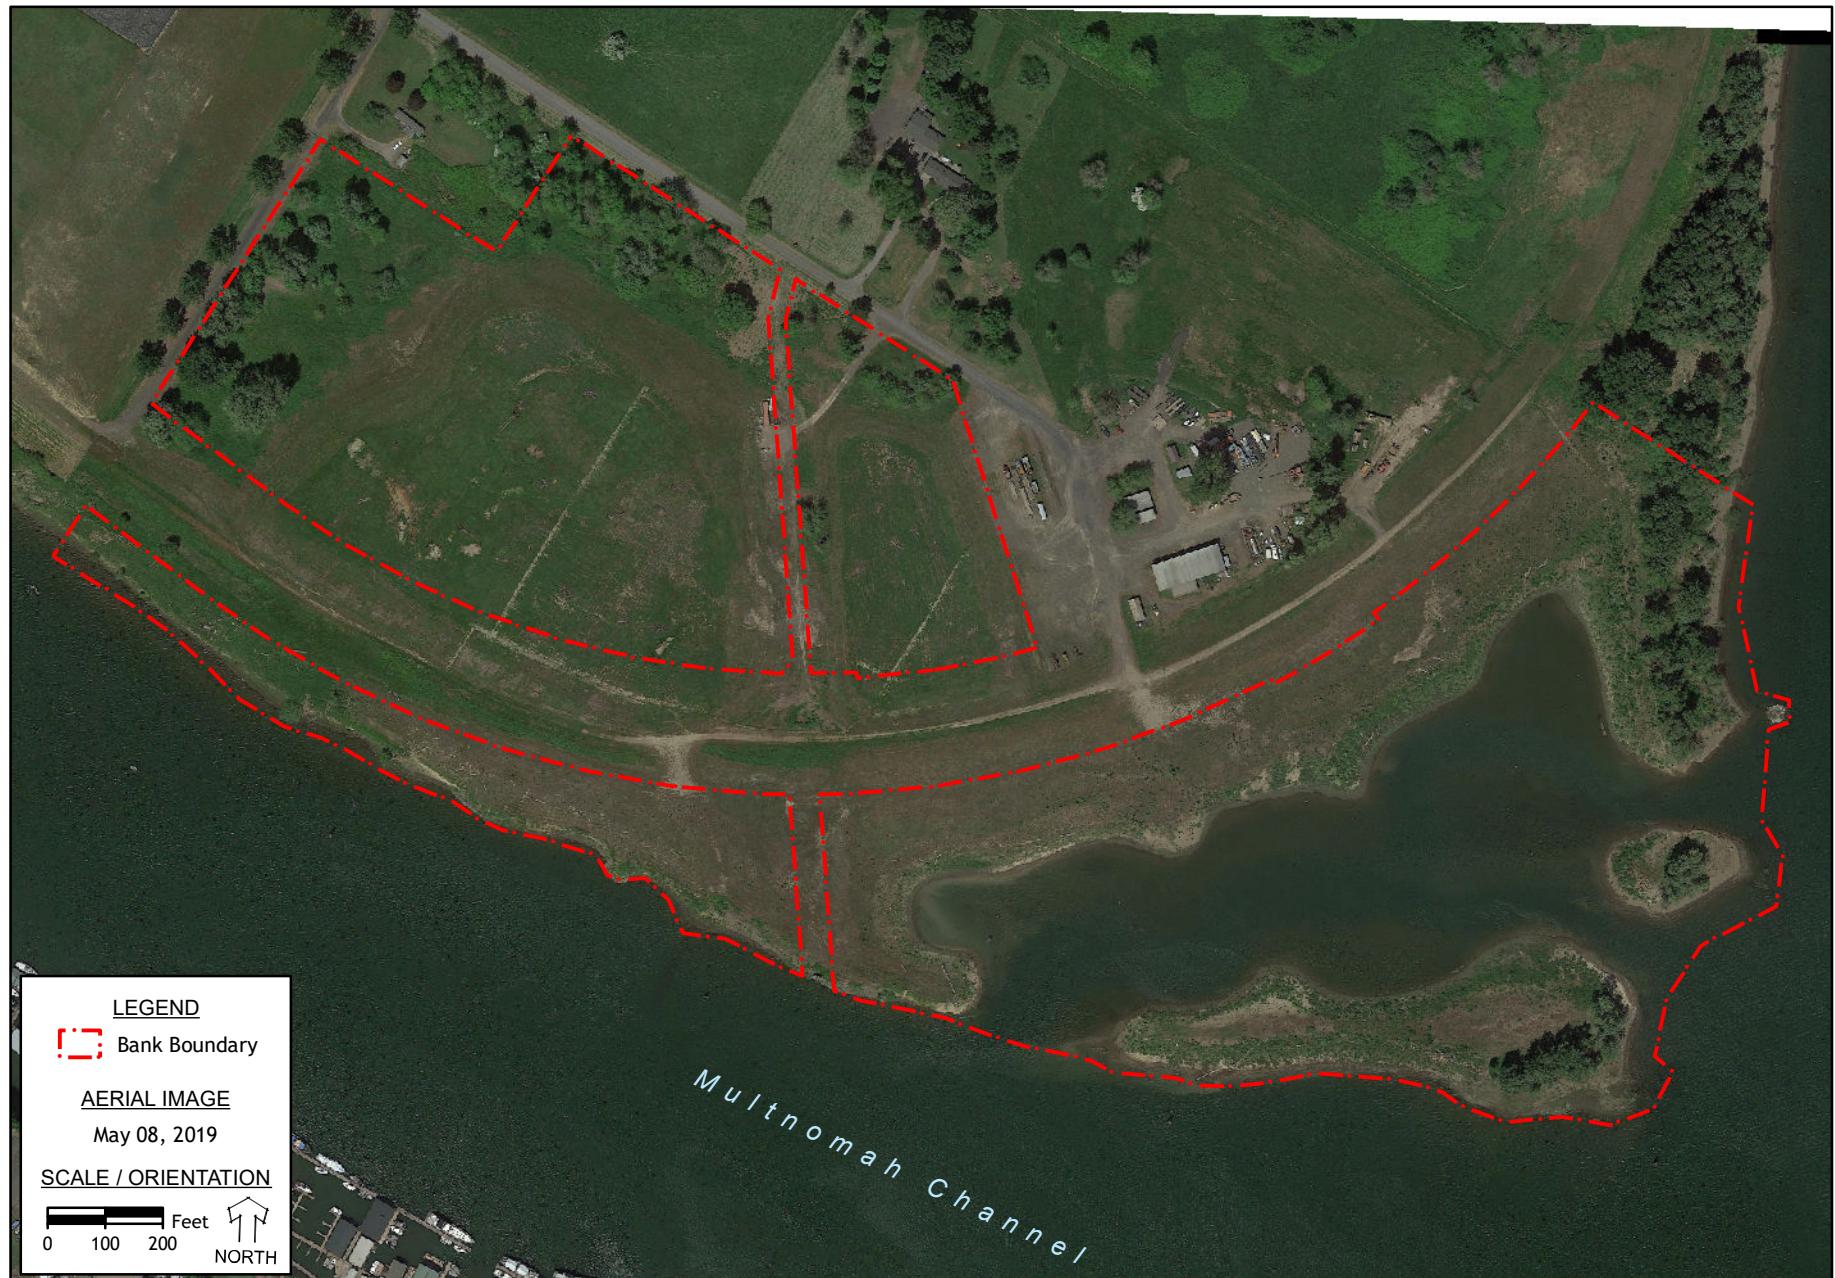
Figure 6c  
Aerial Photo Taken on 05/08/2019

Wildlands' staff again attempted to use a drone to take aerial photos of high water events during the 2019 monitoring period; however, the drone is unable to be used in windy or rainy conditions. Additionally, if there is significant cloud cover, aerial photos cannot be taken. As a result, Wildlands was unable to capture an aerial photo of the site during a high water event; however, a satellite photo was available for 5/8/2019 which was a few days before one of the high water periods of 2019 (**Figure 6c**). Unfortunately, there were no satellite images available when the water level was at or near its highest level (April 12 or May 19 as shown in Figure 6b) which is likely due to inhospitable conditions including wind, rain, and/or cloud cover on and around those days. The water level captured by the satellite photo was translated to GIS to calculate the acres of inundation when the photo was taken. The photo shows approximately 10 acres of ACM inundated on 5/8/2019. The information obtained from the satellite photos was compared to the Columbia Slough gauge data for accuracy. The Columbia Slough gauge data (converted to NAVD 88) shows an approximate water level of 11.42 feet on 5/8/2019 (the day the aerial was taken), and the high water level of 20.5 on 4/12/19. Since the maximum water level was 20.5 (which is over the water level shown in the 2018 aerial photo included with the 2018 report showing approximately 20 acres of inundated ACM), it can be reasonably presumed that the entire ACM acreage was inundated during the high water event of 2019 even though an aerial photo of that event was not obtained.

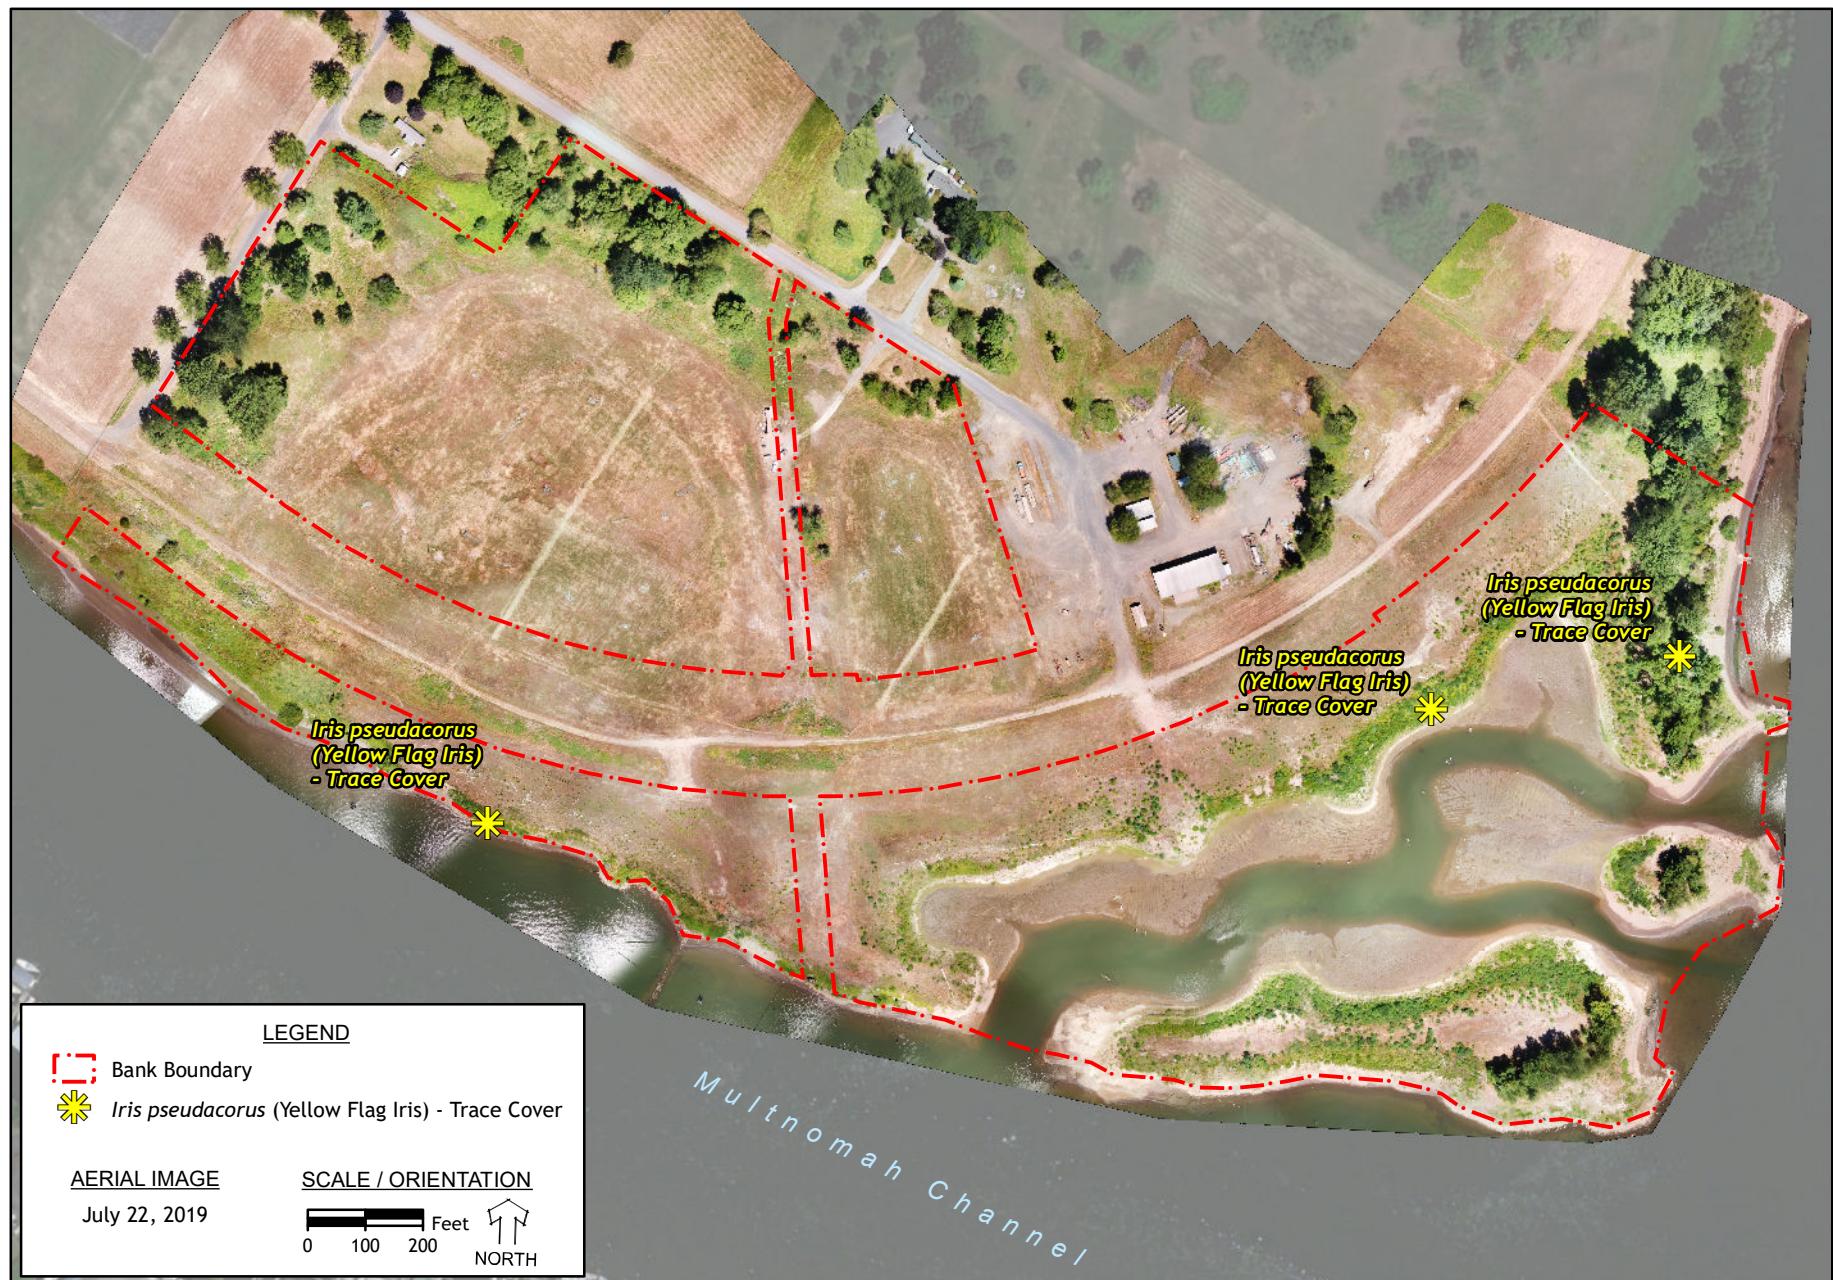
During 2019, Wildlands' biologists visited the Project weekly to look for presence of "zero-untreated species". No giant knotweed, Himalayan knotweed, or butterfly bush was observed on the Project site. A small amount of purple loosestrife and yellow flag iris were identified (See **Figure 7**). All instances of these species were removed (**Table 9**).
