March 25, 2016

Subject: Garret Creek Mitigation Bank, Supplemental Mitigation Monitoring Results

Garret Creek Mitigation Bank - Monitoring Map

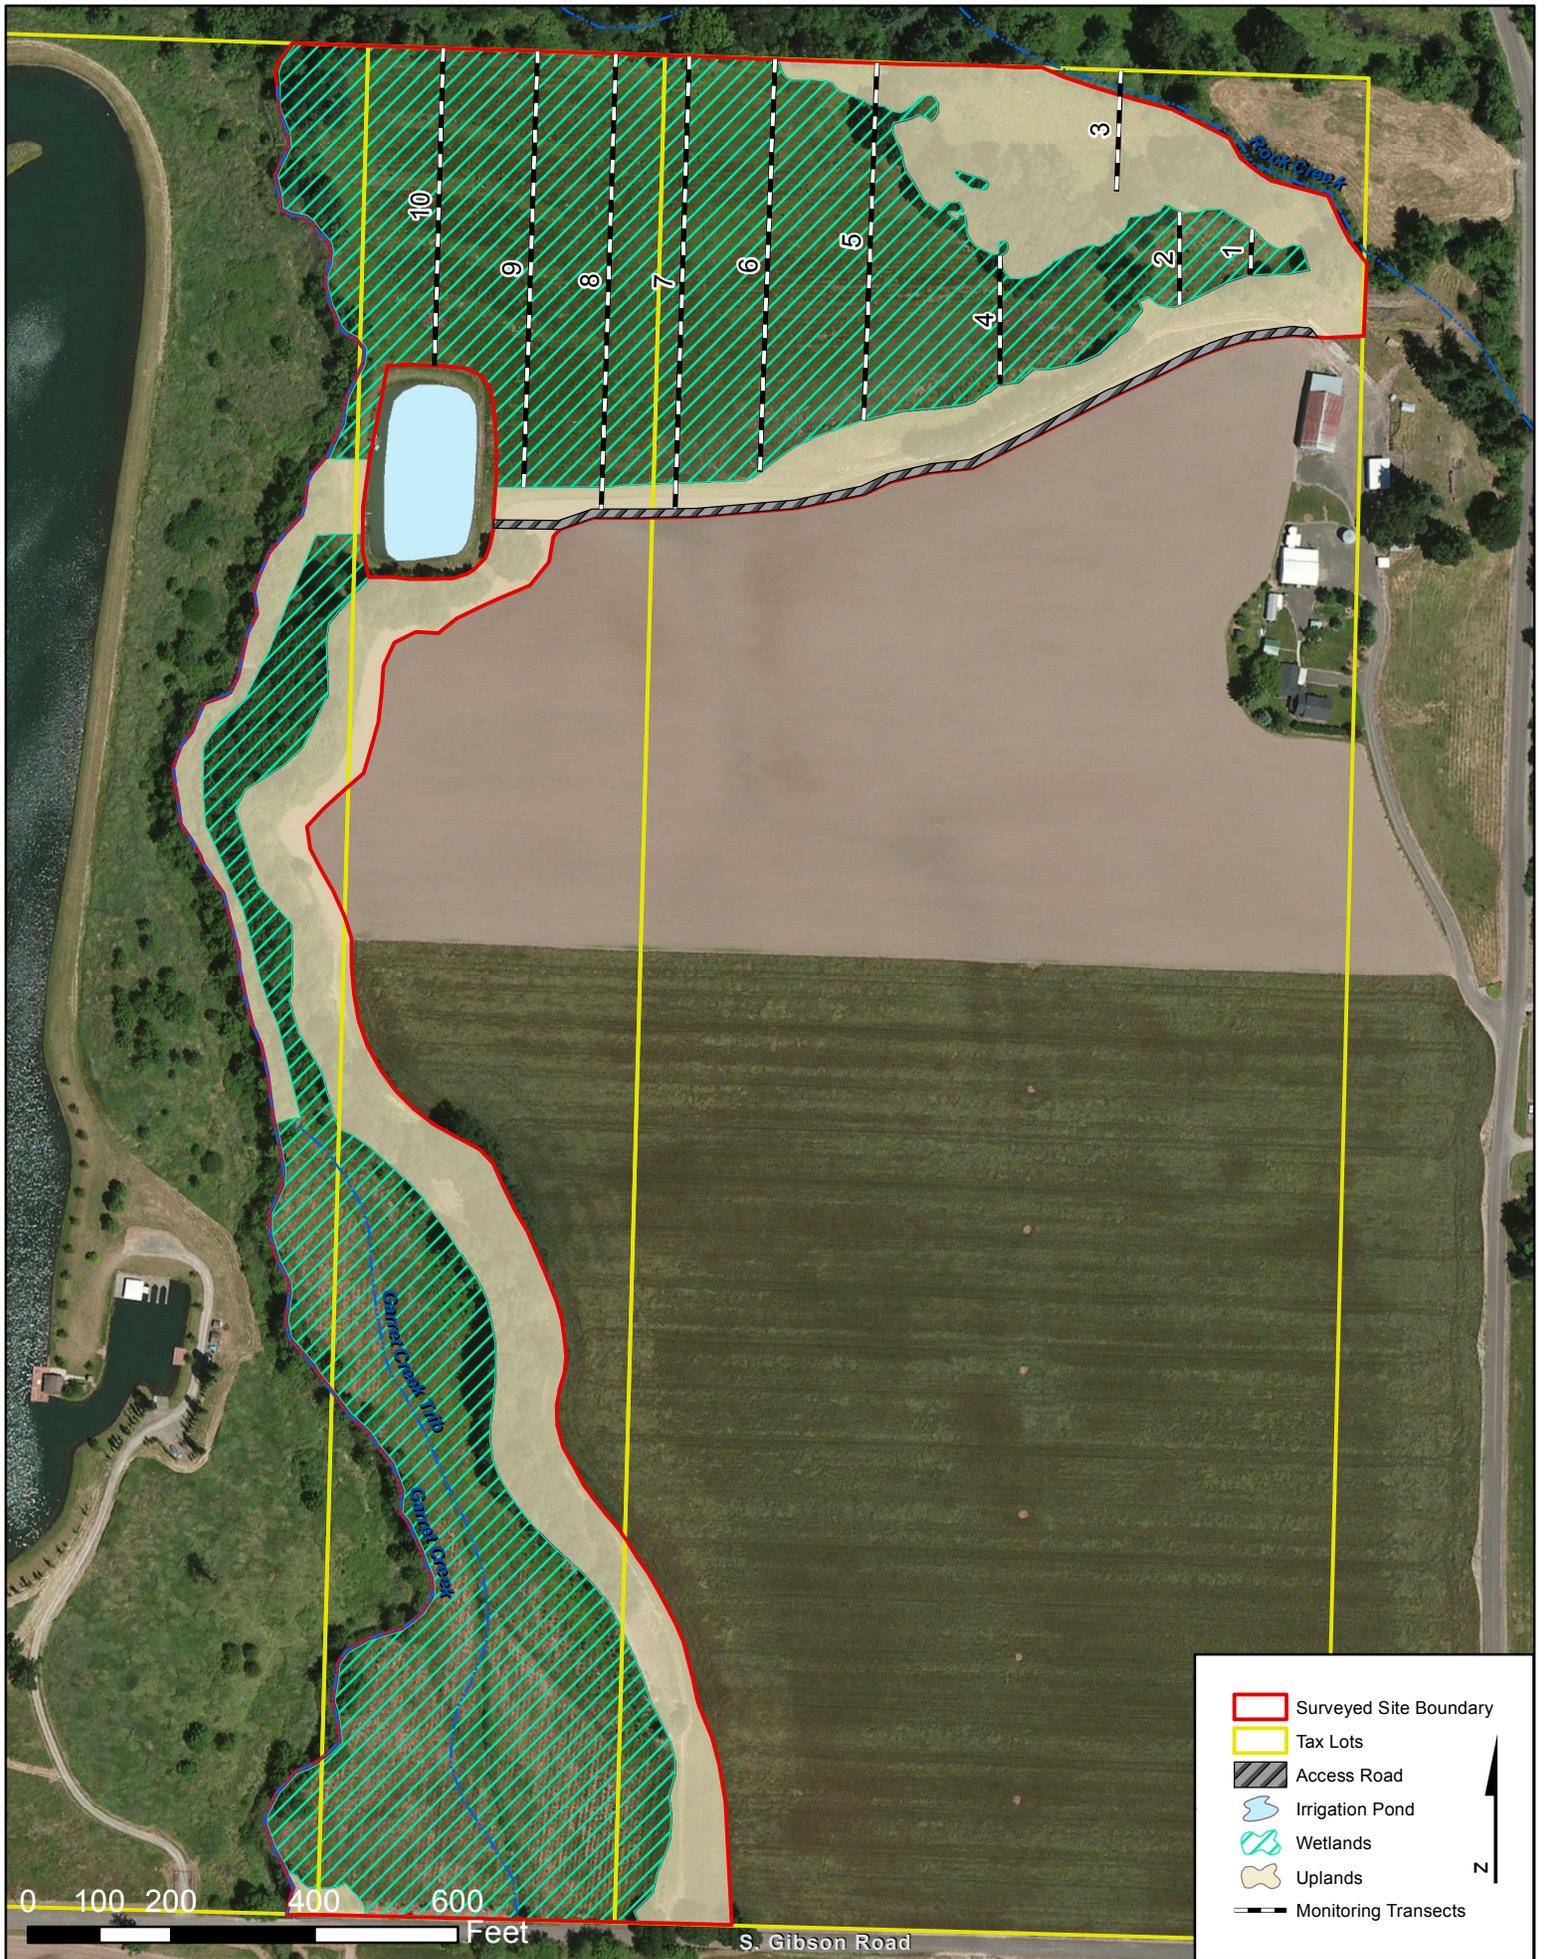
the upland edge of the buffer during construction. The change has no impact on total site area, but establishes more contiguous buffer area, but this detail had not been previously reported – the attached Garret Creek Monitoring Map shows the updated location, along with the location of sampled transects. The Bank is eligible to earn 15.49 wetland mitigation credits and 220 stream credits (each credit is equivalent to 1 cubic yard of fill below the ordinary high water mark). Mitigation bank development included wetland restoration, wetland enhancement, riparian enhancement, stream restoration, and upland buffer enhancement. Table 1 summarizes the areas for each mitigation activity type; detailed explanations of mitigation activities can be found in the Garret Creek MBI, produced by Jones & Stokes Associates in 2008.
