LINNTON MILL RESTORATION SITE

RESTORATION PLAN

DECEMBER 4, 2018

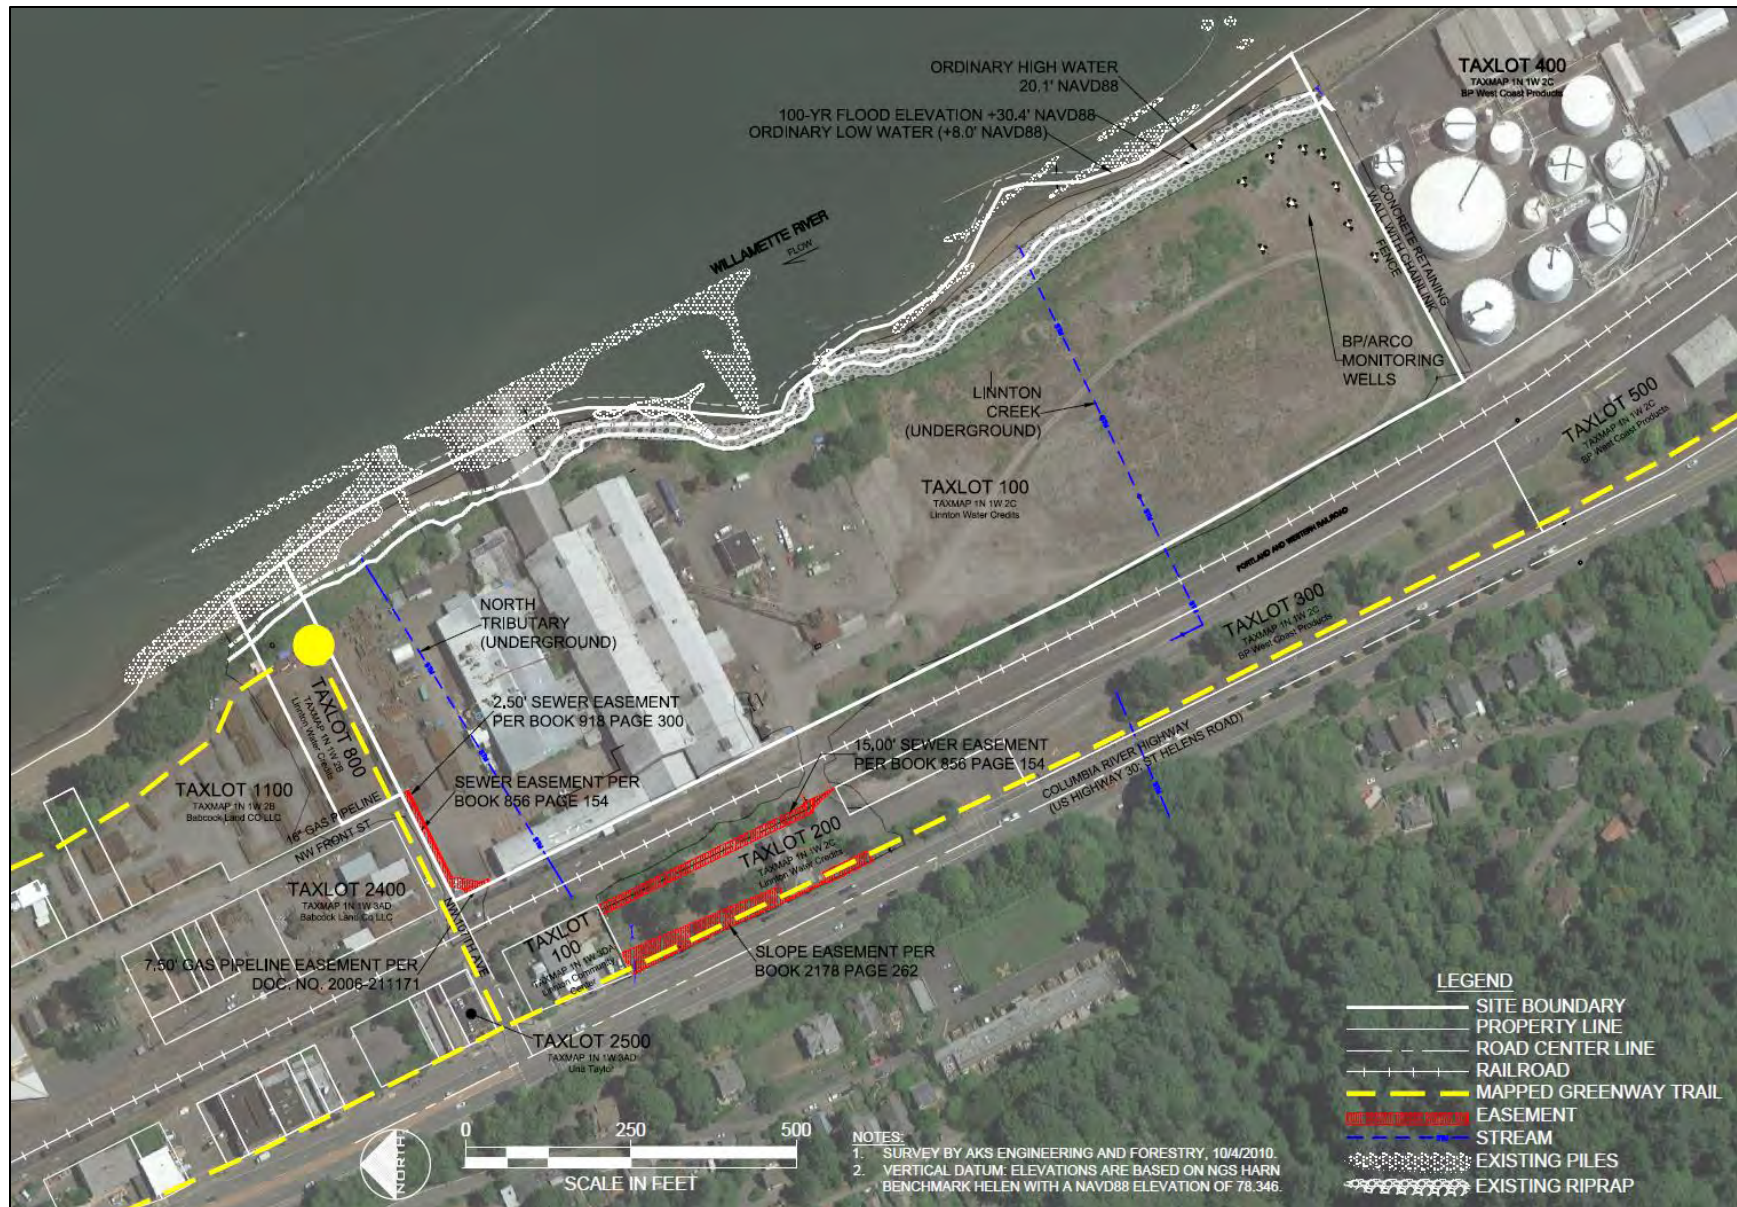
Figure 1. Linnton Mill site

2001, with the southern portion of the property used for stockpiling/dewatering of Columbia River sand from 1997 until recent years (CH2M Hill 2007). Based on historic aerial photos, stockpiling/dewatering operations ended within the past two to three years. Currently, the site includes extensive piles and pile stubs, overwater structures, shoreline armoring, a sheetpile wall, small isolated patches of riparian vegetation, and highly developed and industrial upland.

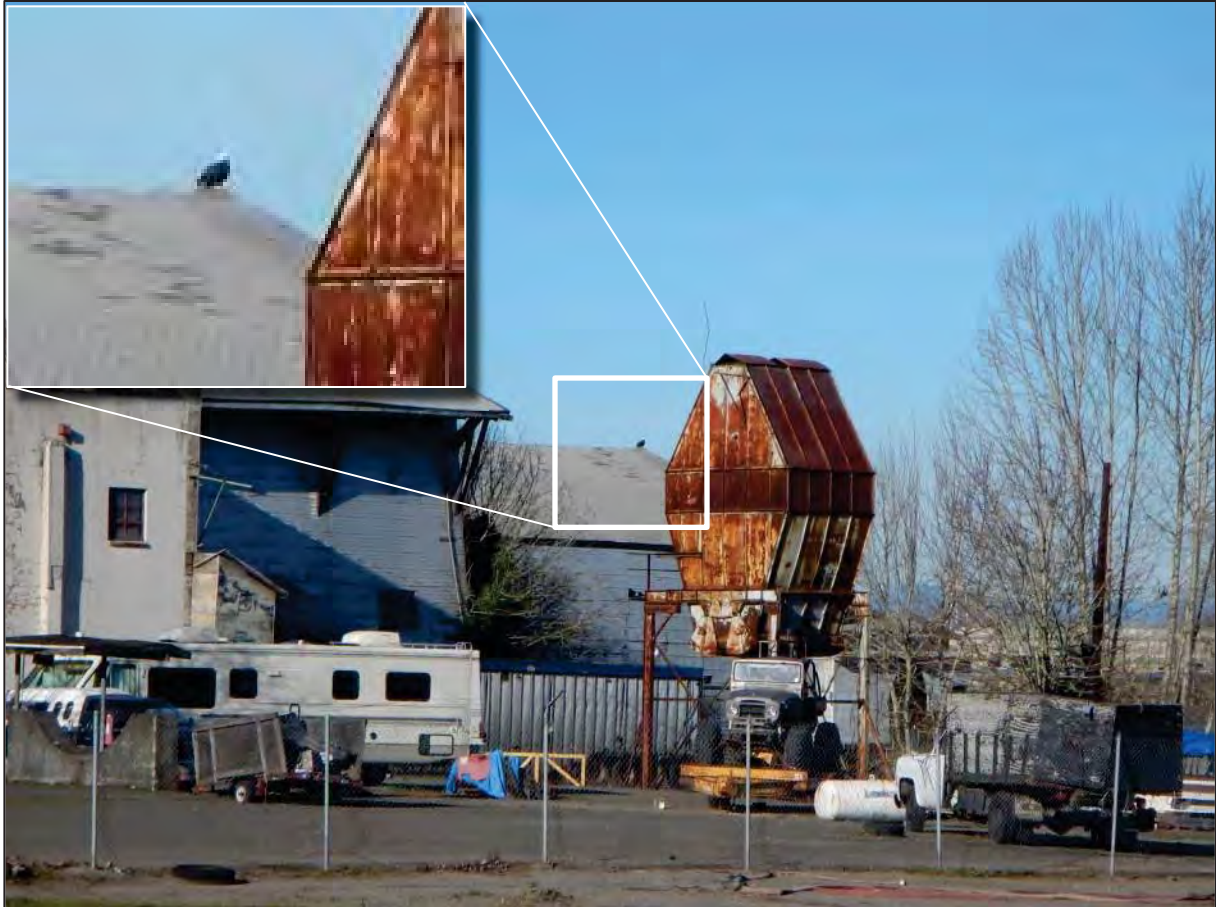
Figure 2. Bald eagle perch.

The only observed use of habitat on the site during the monitoring periods was perching on the riverward corner of the warehouse building¹ (Figure 2). This was observed on 10 occasions in nine surveys. Perching typically consisted of resting or preening activities. On one occasion, two bald eagles were perched at this point, with one remaining for the majority of the survey period, and the other flying away, then returning, then flying away again. On another occasion, an eagle was observed apparently foraging from the perch, as it was observed flying to perch, then minutes later swooping to the shoreline, then flying over the site with food items to the forested hillside to the west. Perching on the building occurred more frequently in the pre-dusk (seven) than the post-dawn (four), but perching made up 80% of all post-dawn sightings and 47% of pre-dusk sightings.

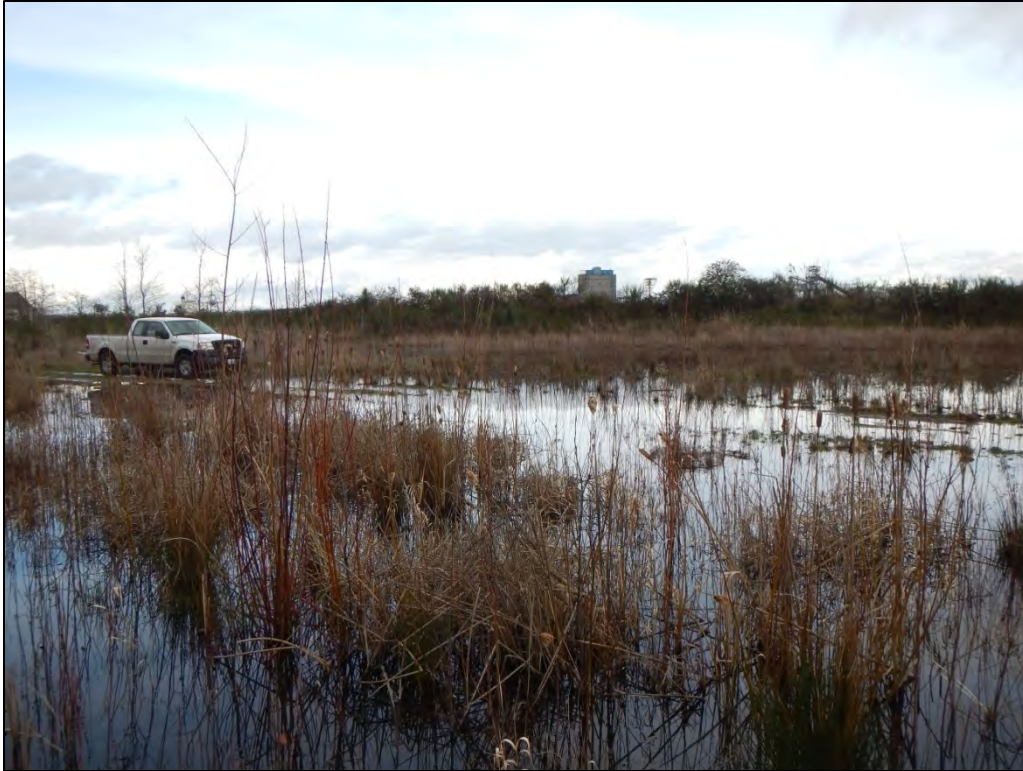
Photograph of Area 1, facing east; berm separating Areas 1 and 2 from the river is visible in the background.

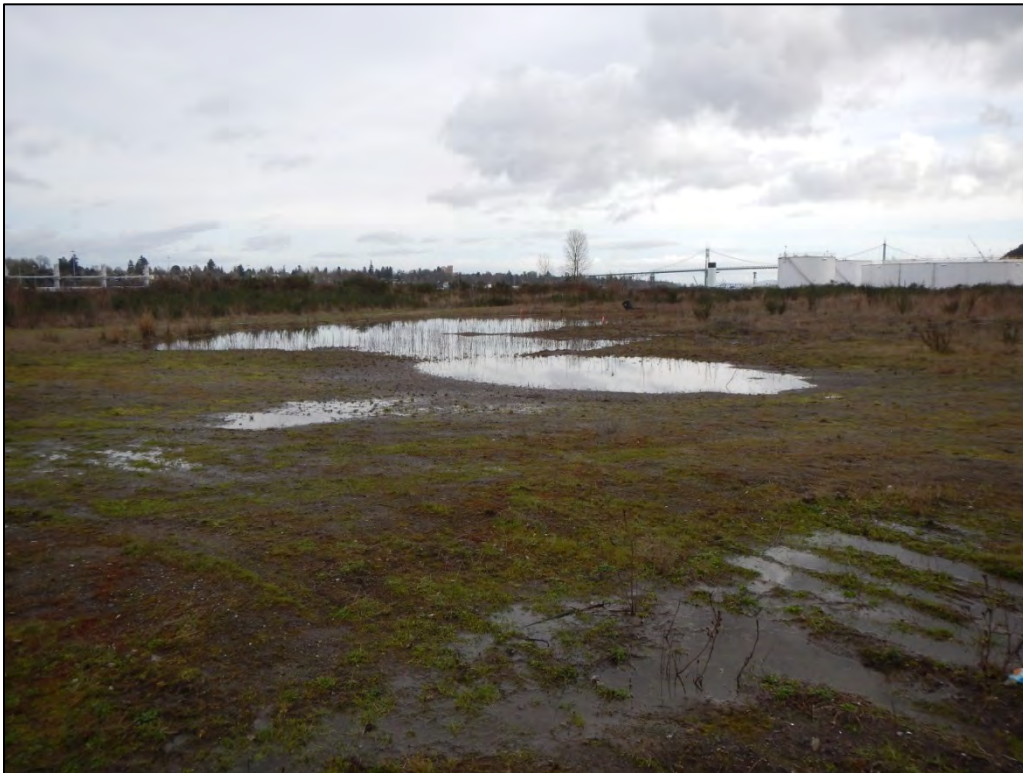
Photograph of Area 2, facing southeast; berm is visible in the background.

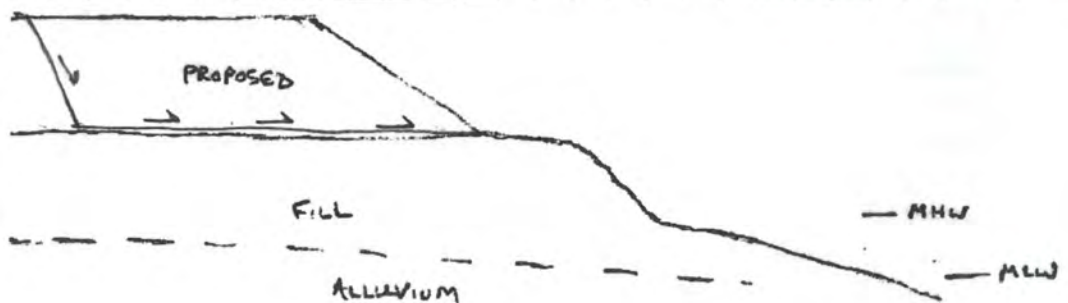
- Again evaluate new embankment only, with block failure on smooth, sloping concrete surface. Compare results to file LINN6.
- Model strength as frictional coeff of 0.35 multiplied by overburden ($c = fN$). Set program to "Vertical Stress Ratio" rather than "Mohr-Coulomb".
- Schematic:

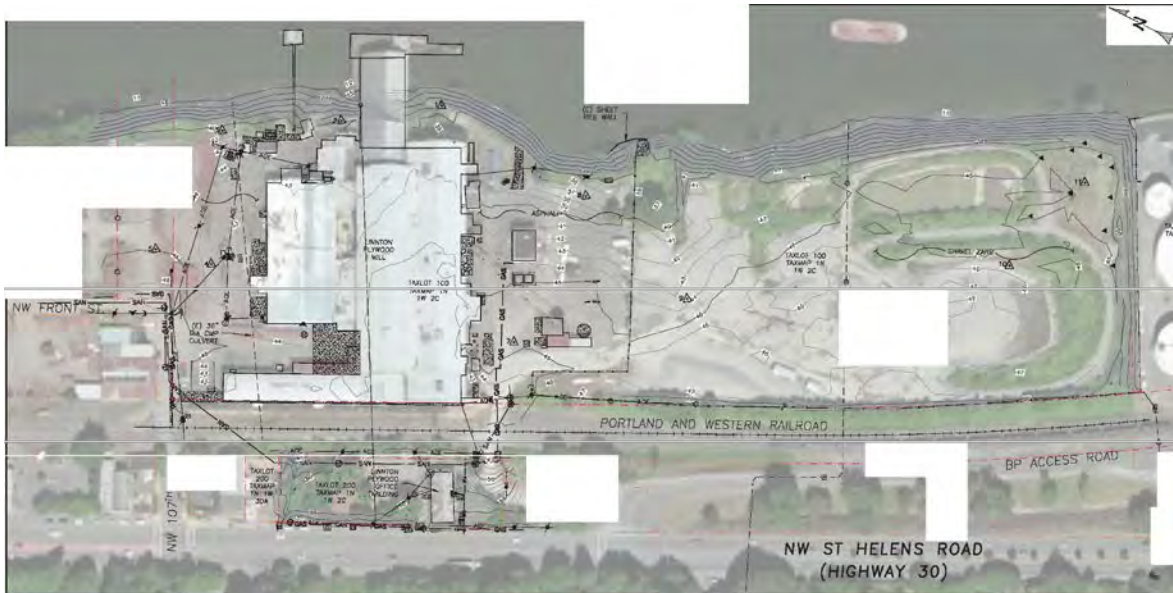
Figure 2. Proposed Linnton restoration project area.

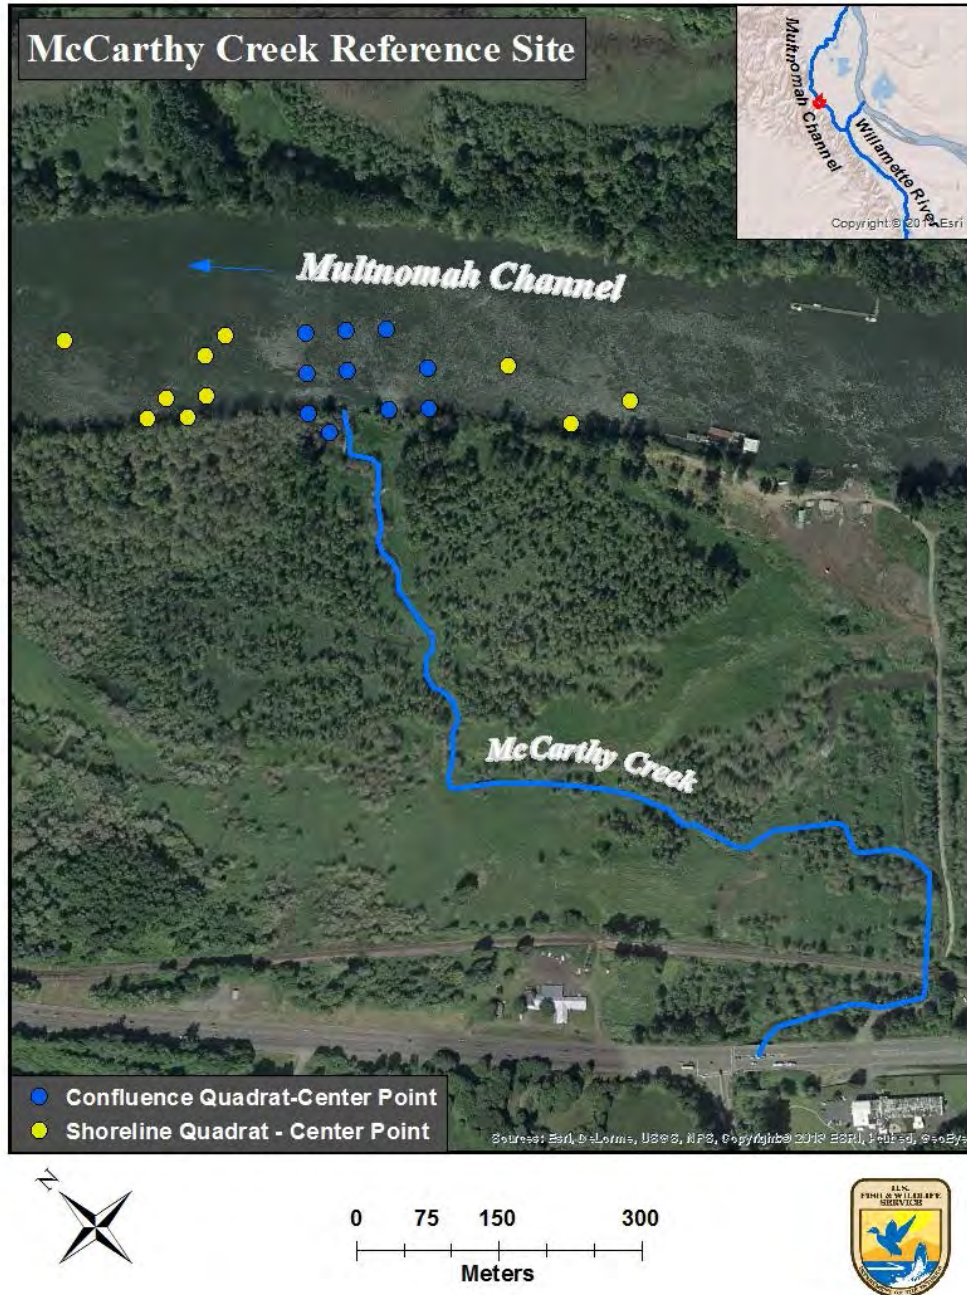
Figure 4. Proposed sample design for the McCarthy Creek reference site. Potential shoreline (100 m band) sample quadrats (yellow points) and confluence sample quadrats (100 m arc, blue points) will be sampled as part of this investigation. Tributary reaches will not be sampled as part of this investigation.
